Low-Cost Shore Protection

Final Report on the Shoreline Erosion Control
Demonstration Program (Section 54)
1981

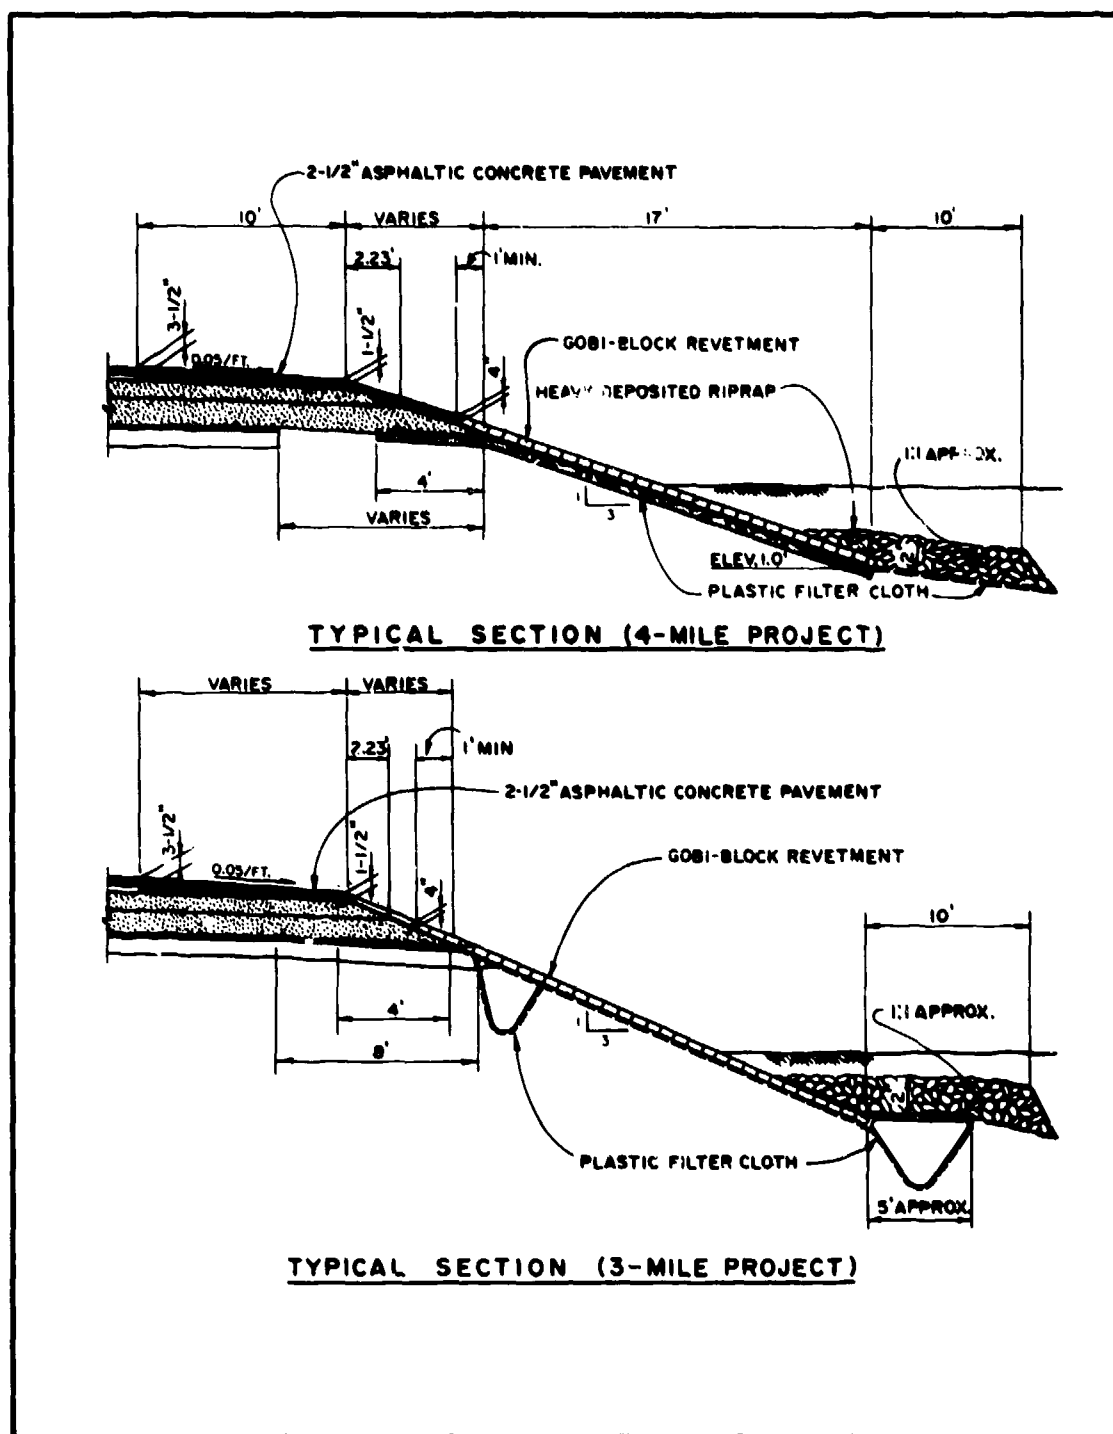
During Tropical Storm Claudette in July 1979, approximately 2 miles of the Gobi-block revetment was displaced or otherwise damaged. In a few

Figure 2-220. Rebuilt 3-mile and 4-mile projects at Holly Beach site.

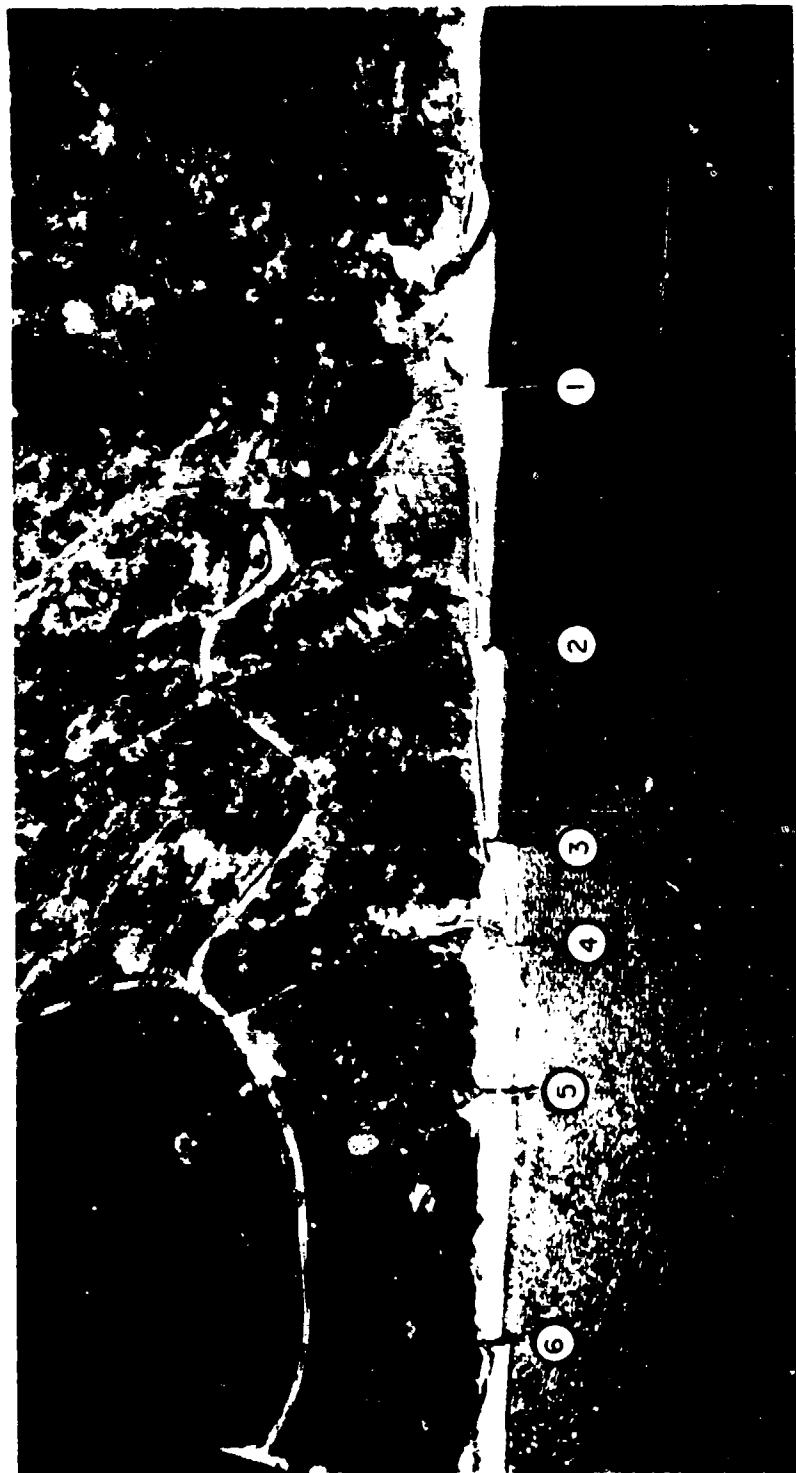
Figure 2-482. Sand accumulation on the updrift sides of the groins, Ashland, Wisconsin, 24 May 1979.
